Installation of the permanent regeneration system – continuous results

The EICERO PID Doctor regeneration system was installed permanently on both converters in the middle of July 2015.

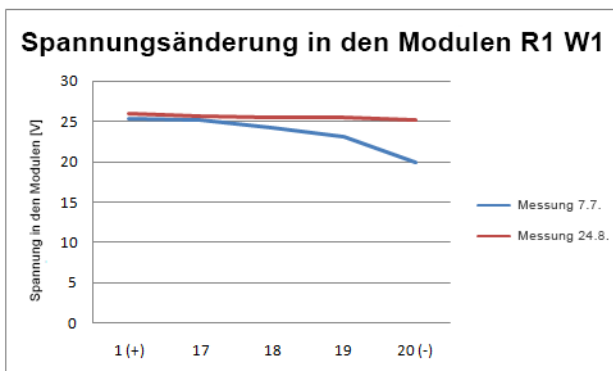
Chart No. 4

Graphic representation of the difference in results as measured prior to and after regeneration.

To verify the effectiveness of the photovoltaic panel regeneration, voltage was measured on several selected strings. The measurement took place on panels that were in use: voltage was measured on the panel closest to the positive string end and on four panels that were the closest to the negative string. The table shows some selected measurements. The string identification "R3 Z2" means "Row 3 String 2" from the west. The data and charts bring evidence of a voltage increase and hence of higher panel output.
